National Pollutant Discharge Elimination System (NPDES)

Reconnaissance and Compliance Sampling Inspection Report Associated with Unpermitted Animal Feeding Operation

**Project Name: Tasty Pigs
53062 Highway 78
Hammett, Idaho 83627**

NPDES Unpermitted Tracking Number: IDU000466

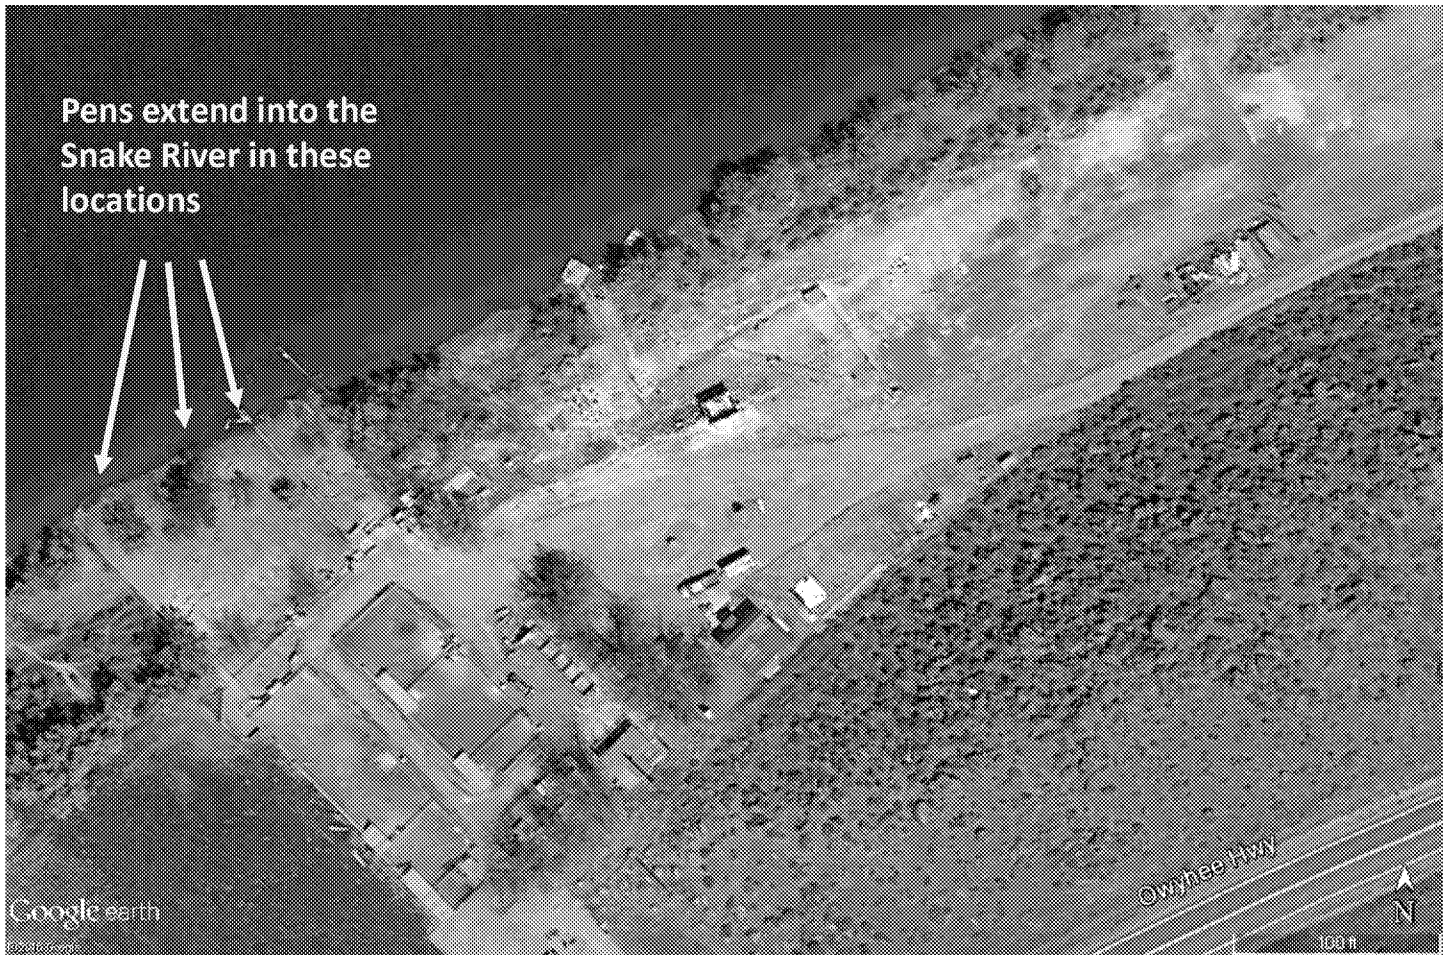
Photo No. 3 – from Google Earth Pro (satellite imagery date 05/29/2015)
Pig pens extending into the Snake River are obvious in this aerial photo.

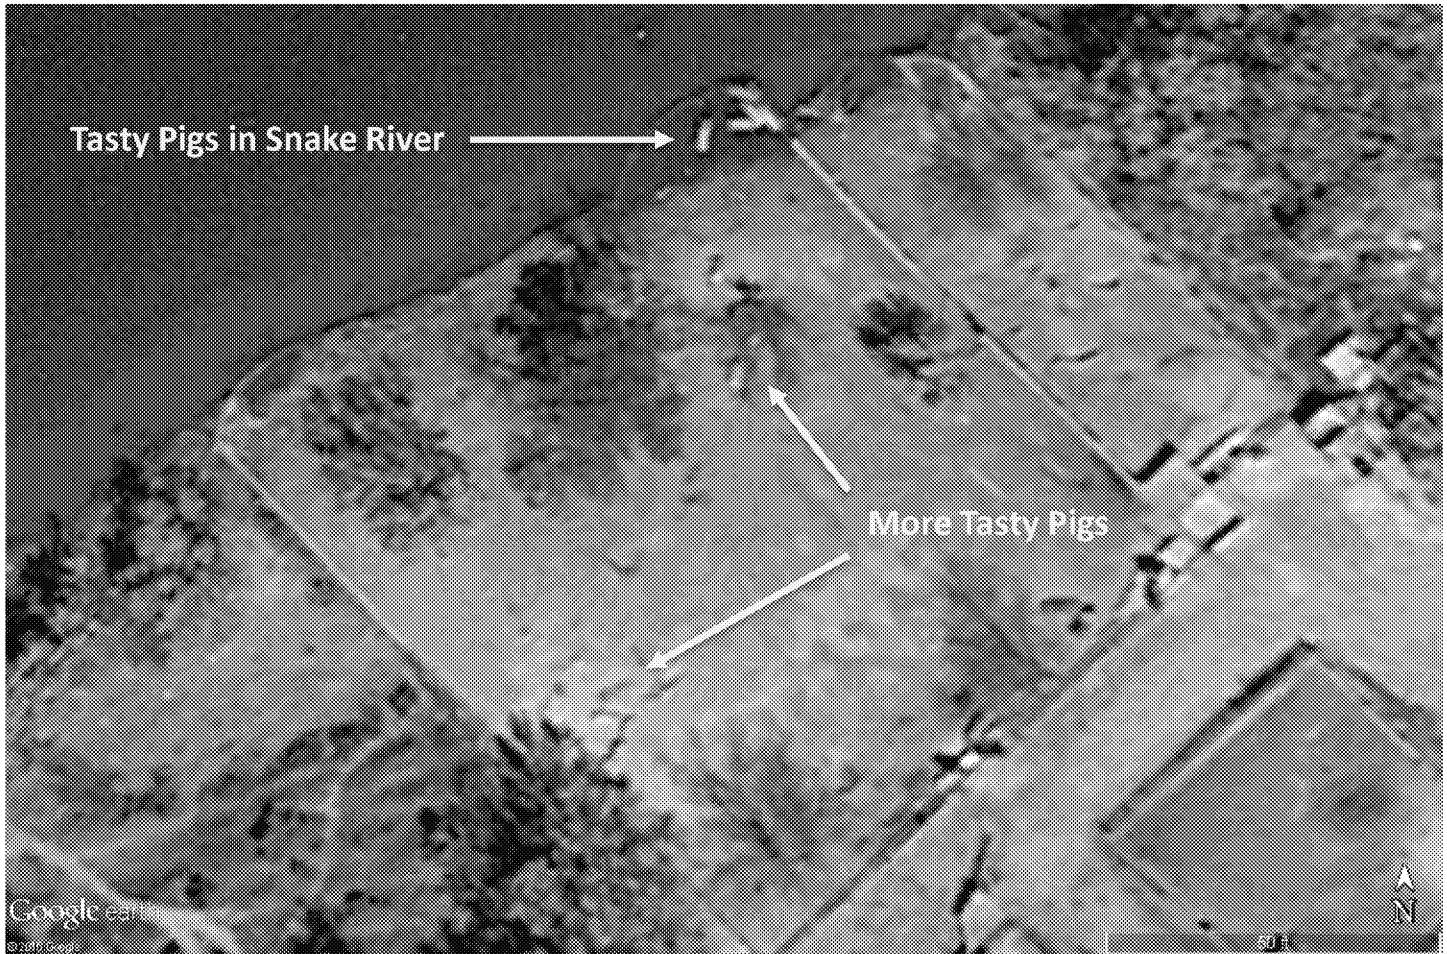
Photo No. 4 – from Google Earth Pro (satellite imagery date 05/29/2015)
Though the resolution is poor at this magnification, the presence of pigs in the river is obvious.

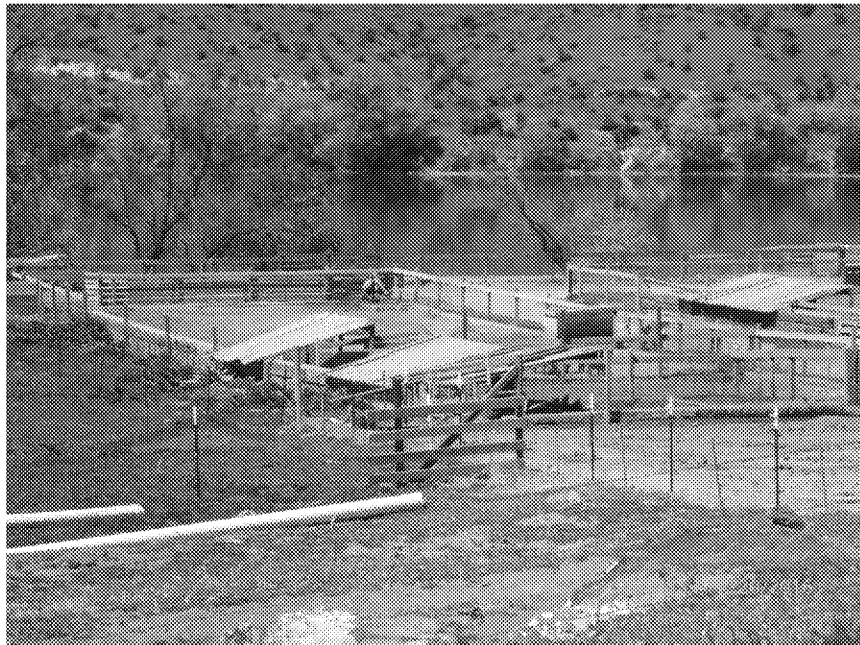
Photo No. 6 (P1020107)
Facing north – the Tasty Pigs pens become visible from the highway a short distance west of the driveway.

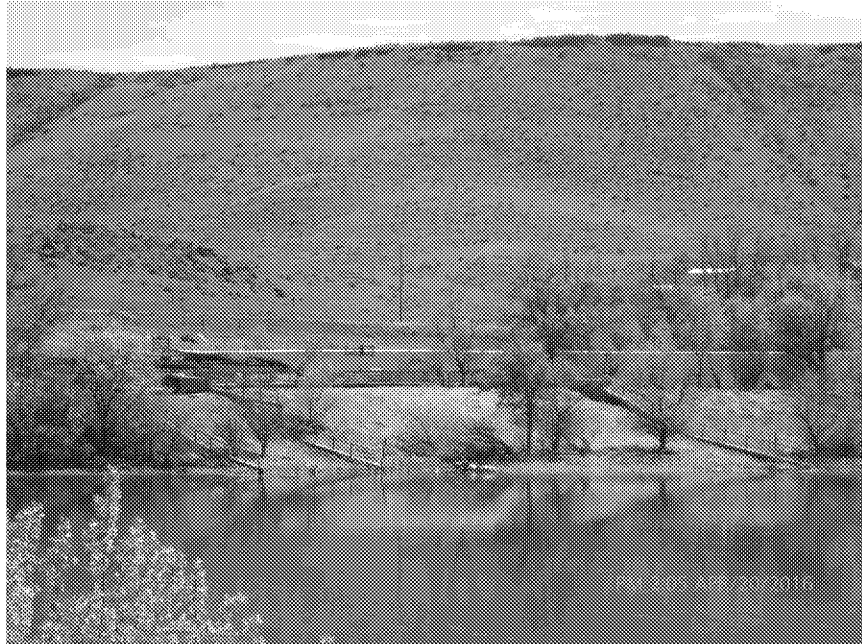
Photo No. 7 (P1020110)

Land use maps identify the property on the north side of the Snake River as public land administered by the Bureau of Land Management (BLM). Just before we crossed the Highway 78 bridge noted previously, we had observed a dirt road heading west along the north side of the river. Once we knew we had the correct location, Nick and I decided to drive back across the bridge to see if the road would put us into position across from the Tasty Pigs operation. Crossing the bridge, we turned left (west) onto the dirt road and drove a little less than a half mile until we reached a point directly across from Tasty Pigs. From that location we observed a handful of pigs wading in the river and wallowing in the mud along its banks (see Photos 7-10).

Facing south – this view of the Tasty Pigs operation was recorded from BLM property on the north side of the Snake River.

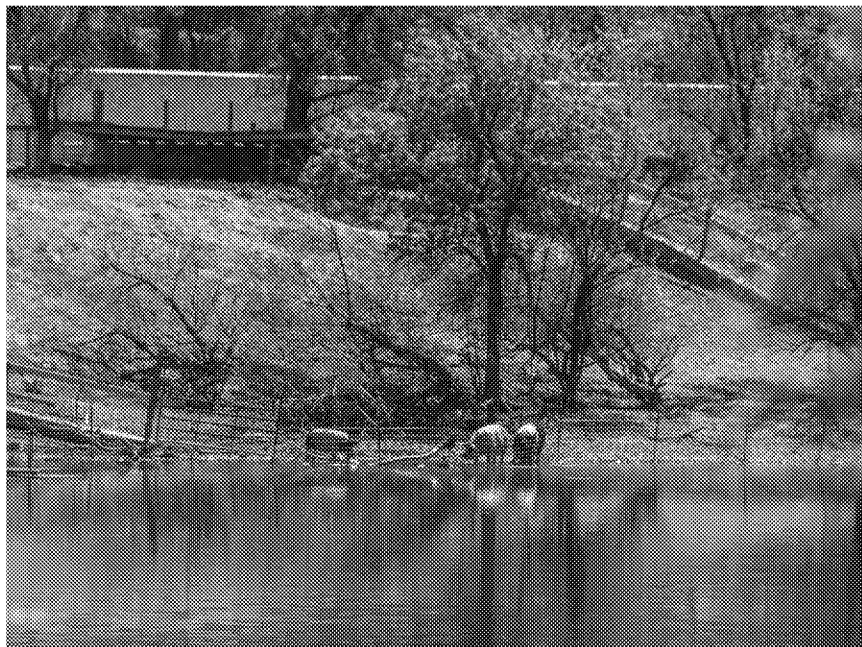
Photo No. 8 (Nikon D 60; #DSC-0262)

Facing south - this view of the Tasty Pigs operation was recorded from BLM property on the north side of the Snake River.

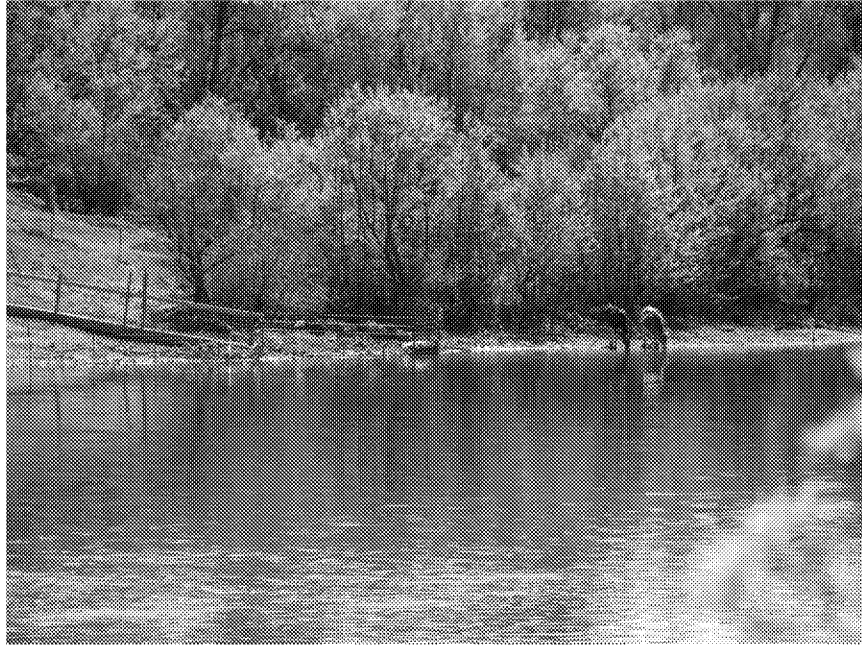
Photo No. 9 (Nikon D 60; #DSC-0228)
Facing south - this view of the Tasty Pigs operation was recorded from
BLM property on the north side of the Snake River.

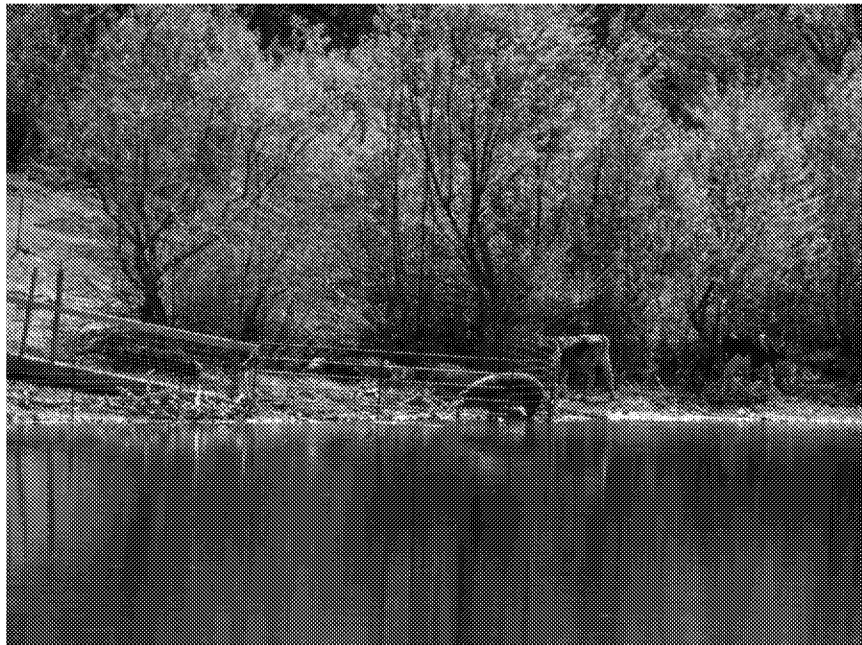
Photo No. 10 (Nikon D 60; #DSC-0239)
Facing south - this view of the Tasty Pigs operation was recorded from
BLM property on the north side of the Snake River.

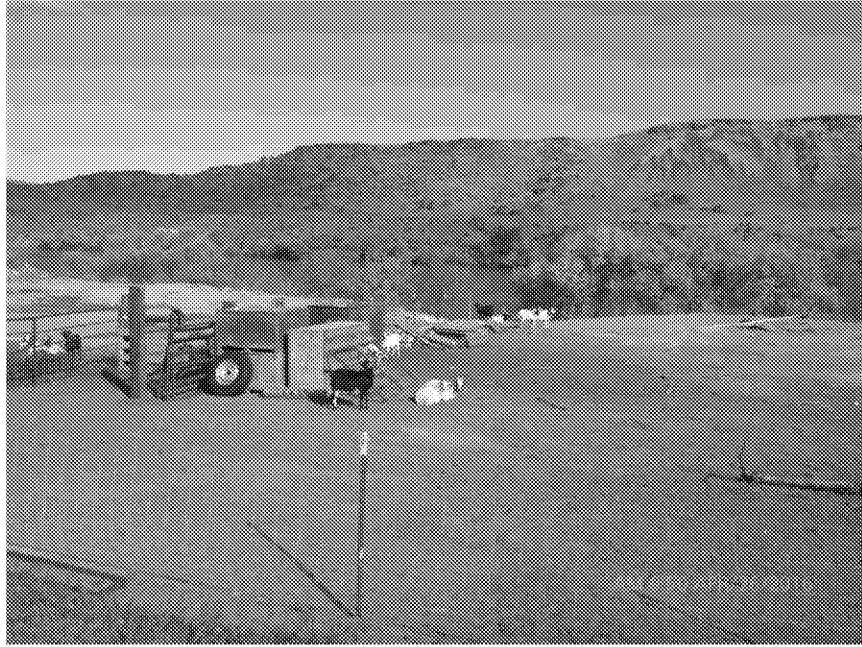
Photo No. 11 (P1020116)

Facing northwest – this is the goat pen; the first pen we passed as we drove into the site. Though the riparian area appeared relatively intact, Mr. Carpenter acknowledged that the goats do have access to the river.

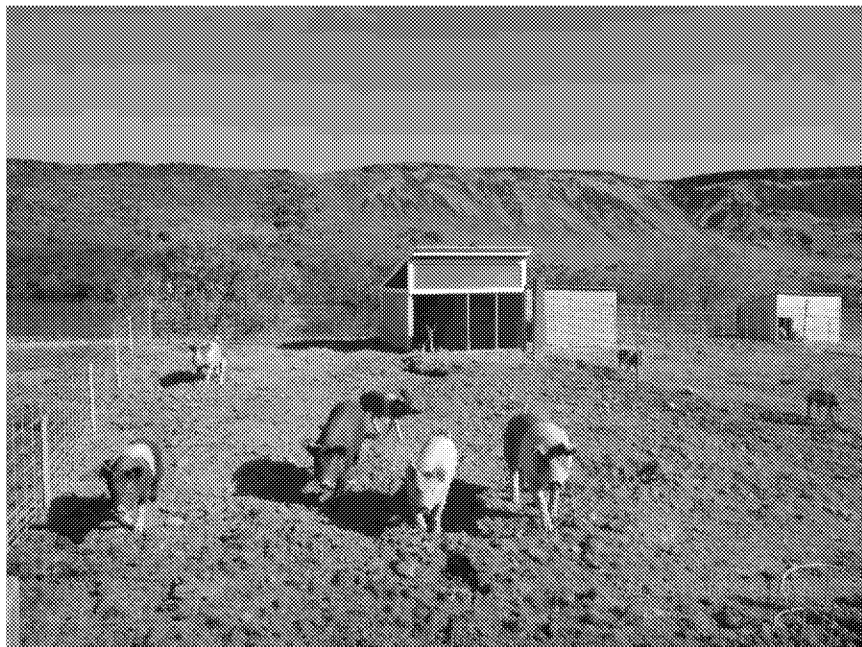
Photo No. 12 (P1020118)

Facing north – this is one of the many pens on the east side of the Tasty Pigs operation (immediately west of the goat pen) housing smaller pigs. These pens did not have direct access to the river.

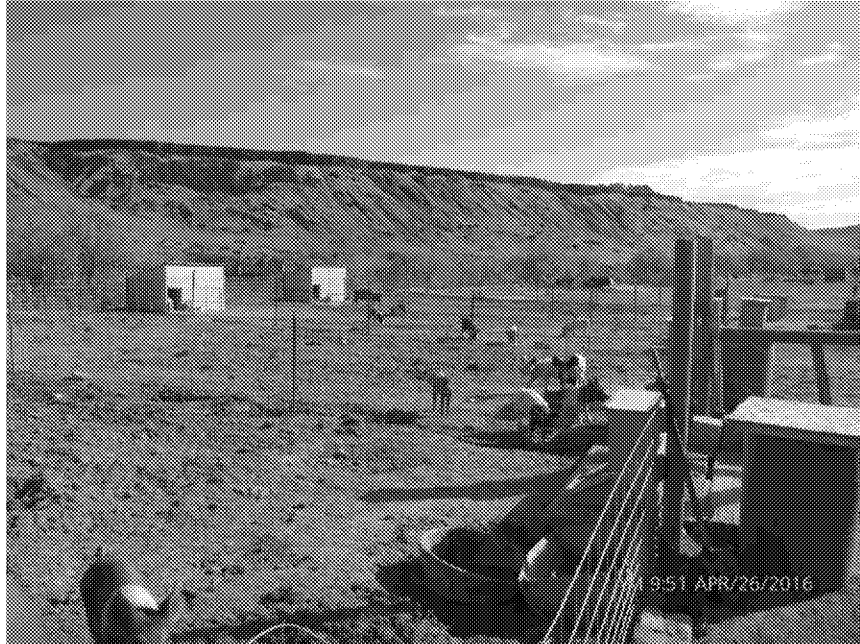
Photo No. 13 (P1020119)

Facing northeast – this is another of the smaller pig pens located on the east side of the Tasty Pigs operations.

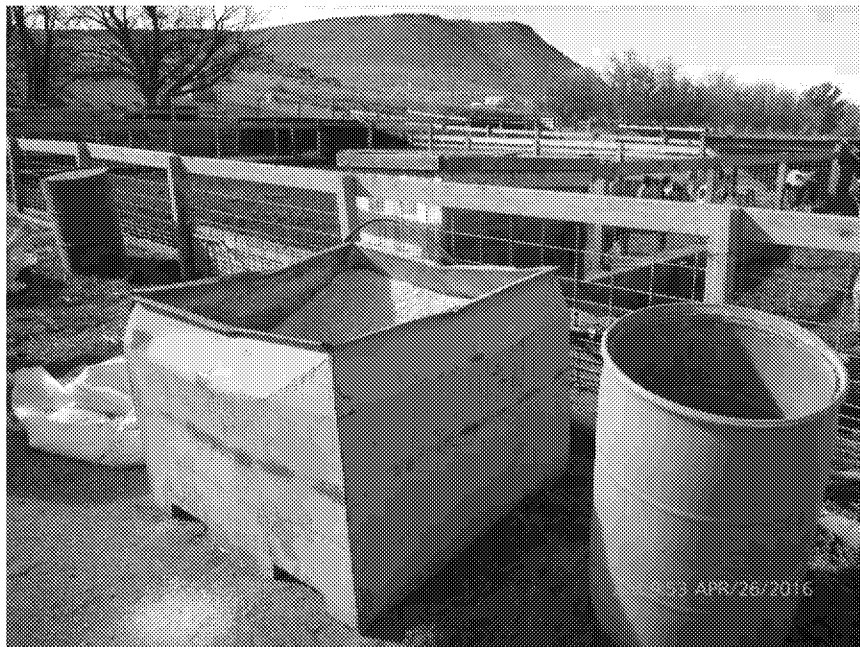
Photo No. 14 (P1020120)

- Pigs are confined at all times and are present throughout the year.
- Pigs are fed corn and soybean meal along with hydroponic fodder (germinated wheat seed) grown on-site (see Photos 14-16).

Facing southwest – corn and soy bean meal are stored in the bin and plastic barrel located near the central portion of the Tasty Pigs operation.

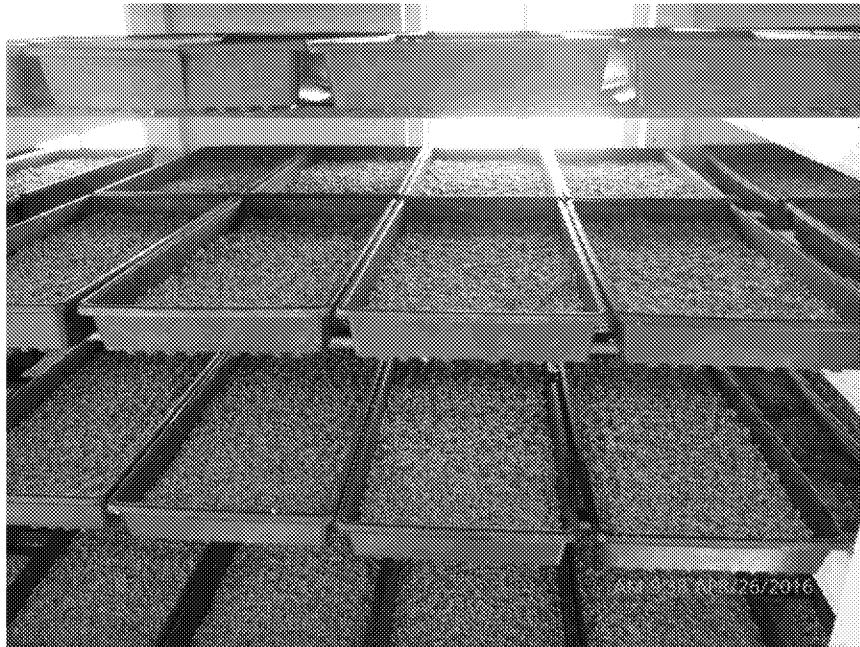
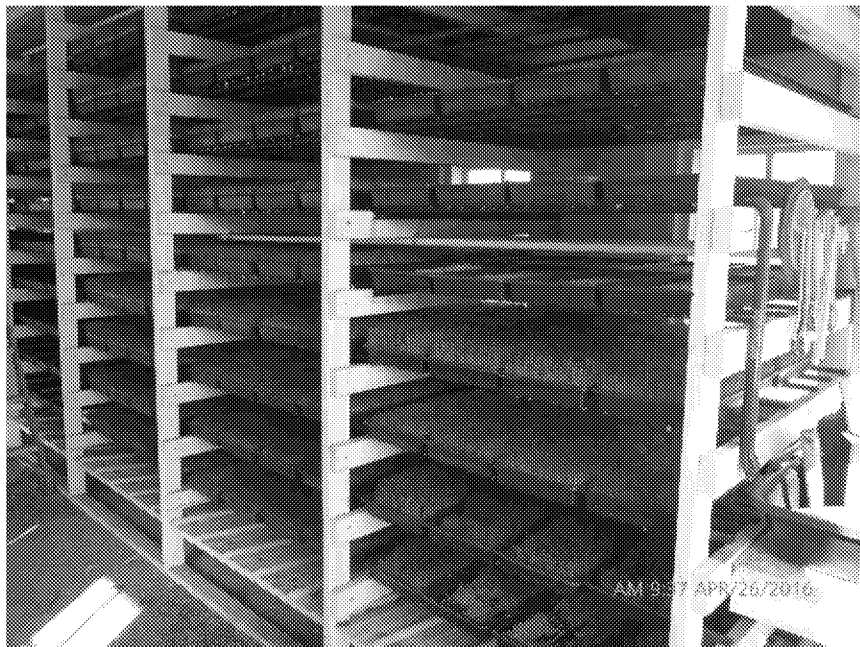
Photo No. 15 (P1020112)
“Hydroponic Fodder” (germinated wheat seed) is produced
for use as pig feed in these trays on-site.

Photo No. 16 (P1020111)
“Hydroponic Fodder” (germinated wheat seed) is produced
for use as pig feed in these trays on-site.

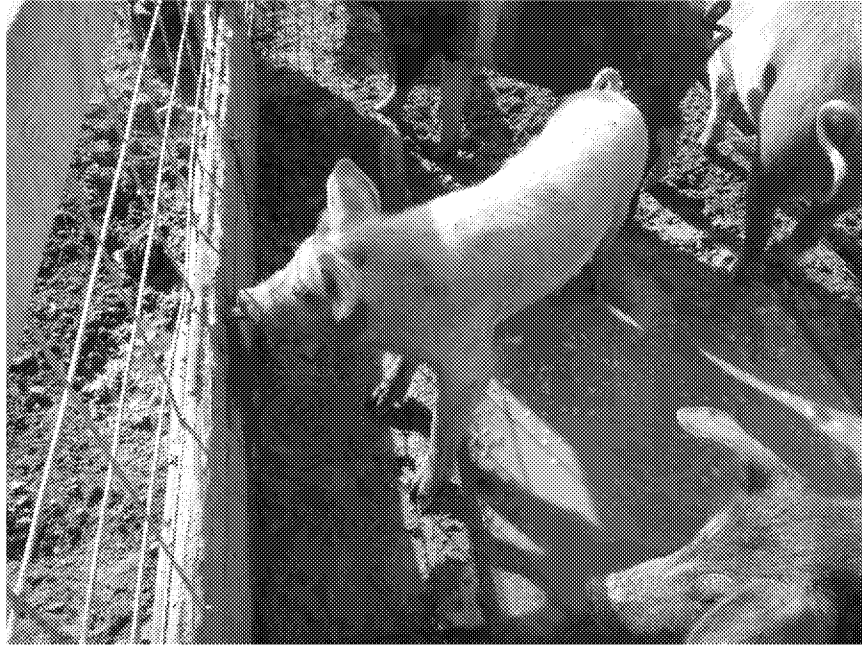
Photo No. 17 (P1020126)

- Water is pumped to a storage tank located on a hillside above the pens. From the tank, water is piped to many of the pens. In these pens, pigs drink from nipples located within the pens (see Photo 17).

With the exception of the pens that extend into the river, most of the pens at the Tasty Pigs facility are equipped with watering nipples gravity fed from an elevated water tank.

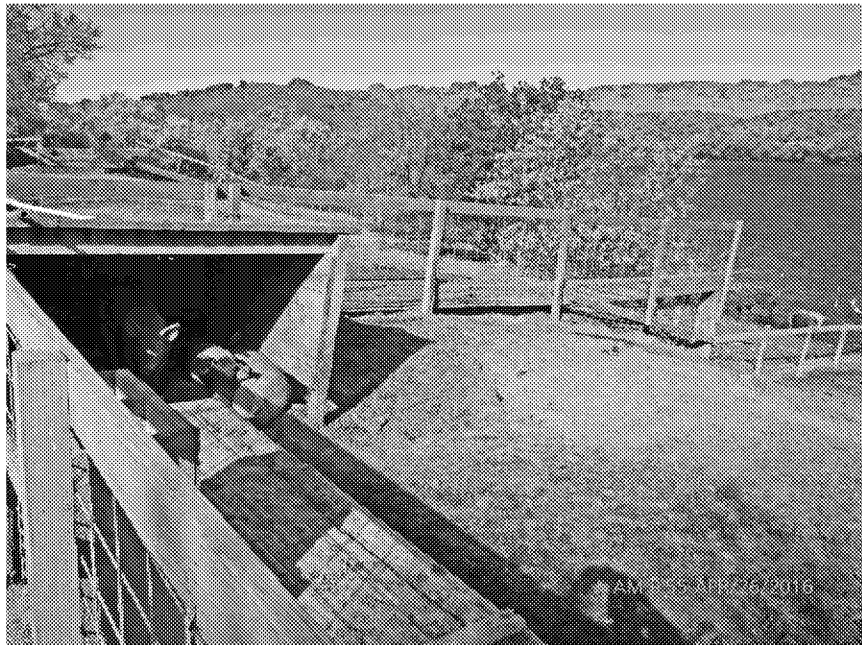
Photo No. 18 (P1020124)

- Some of the larger pigs/hogs are kept in pens located directly adjacent to the Snake River. The pigs in these pens have immediate access to the river.

Facing northwest – this is easternmost of the pens extending into the Snake River. Note the presence of pigs in the river in the adjacent pen (the source for sample # 16174003).

In any event, we suggested to Mr. Carpenter that it would clearly be wise to take steps to prevent the pigs from having access to the river. On that note, we thanked him for his time and cooperation. We left Tasty Pigs at 12:00 pm to deliver the samples to the lab in Boise.

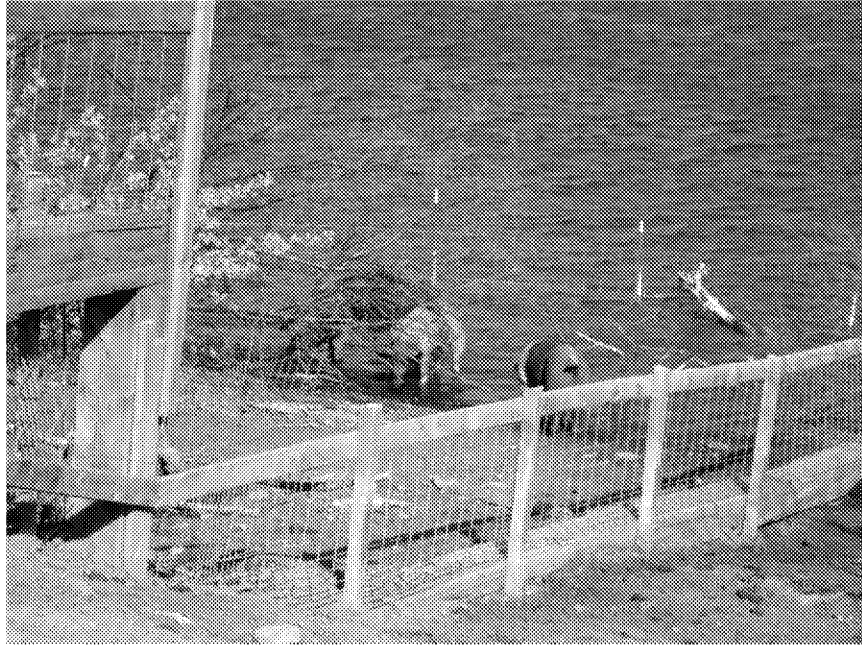
Photo No. 19 (P1020123)

The last sample collected was the sample of river water obtained from within one of the pig pens. Mr. Carpenter assisted with the collection of this sample. Before we entered the pen, Mr. Carpenter tossed out a few flats of the germinated wheat into the upper (southeast) corner of the pen. To the hogs in the pen, this was evidently a tasty delicacy; they scrambled back up the bank, away from the area where we would be collecting our sample set (sample # 16174003). With the hogs momentarily distracted, we were able to collect our sample without any porcine interference.

Facing northwest – once the pigs/hogs were lured away from the river, we collected sample # 16174003 from a location near the outermost fence.

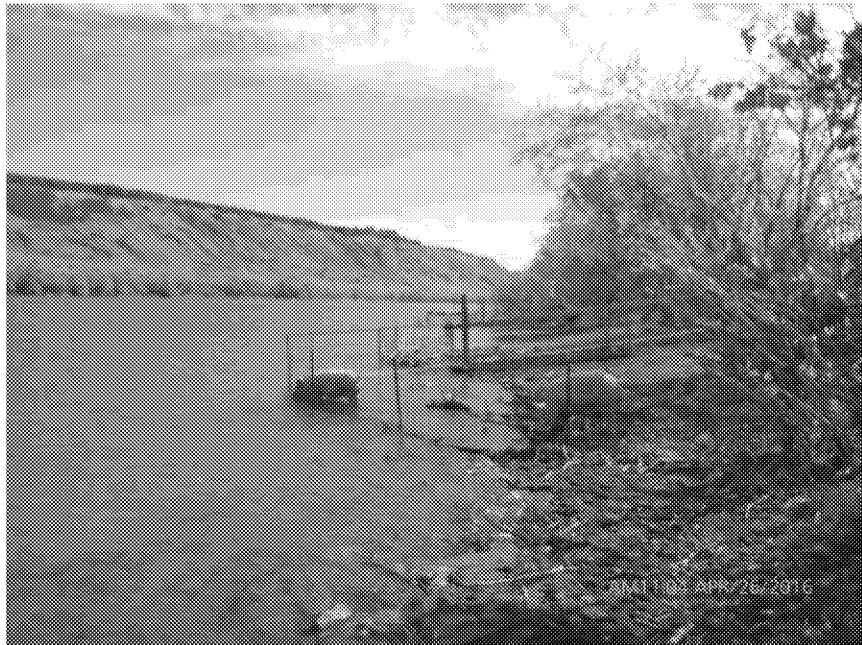
Photo No. 20 (P1020134)

The next sample set (sample # 16174002) was collected from a location approximately 50' downriver from the last of the riverside pens. I also chose this location to create a transfer blank.

Facing east – sample # 16174002 was collected approximately 50' downstream from this westernmost pen.

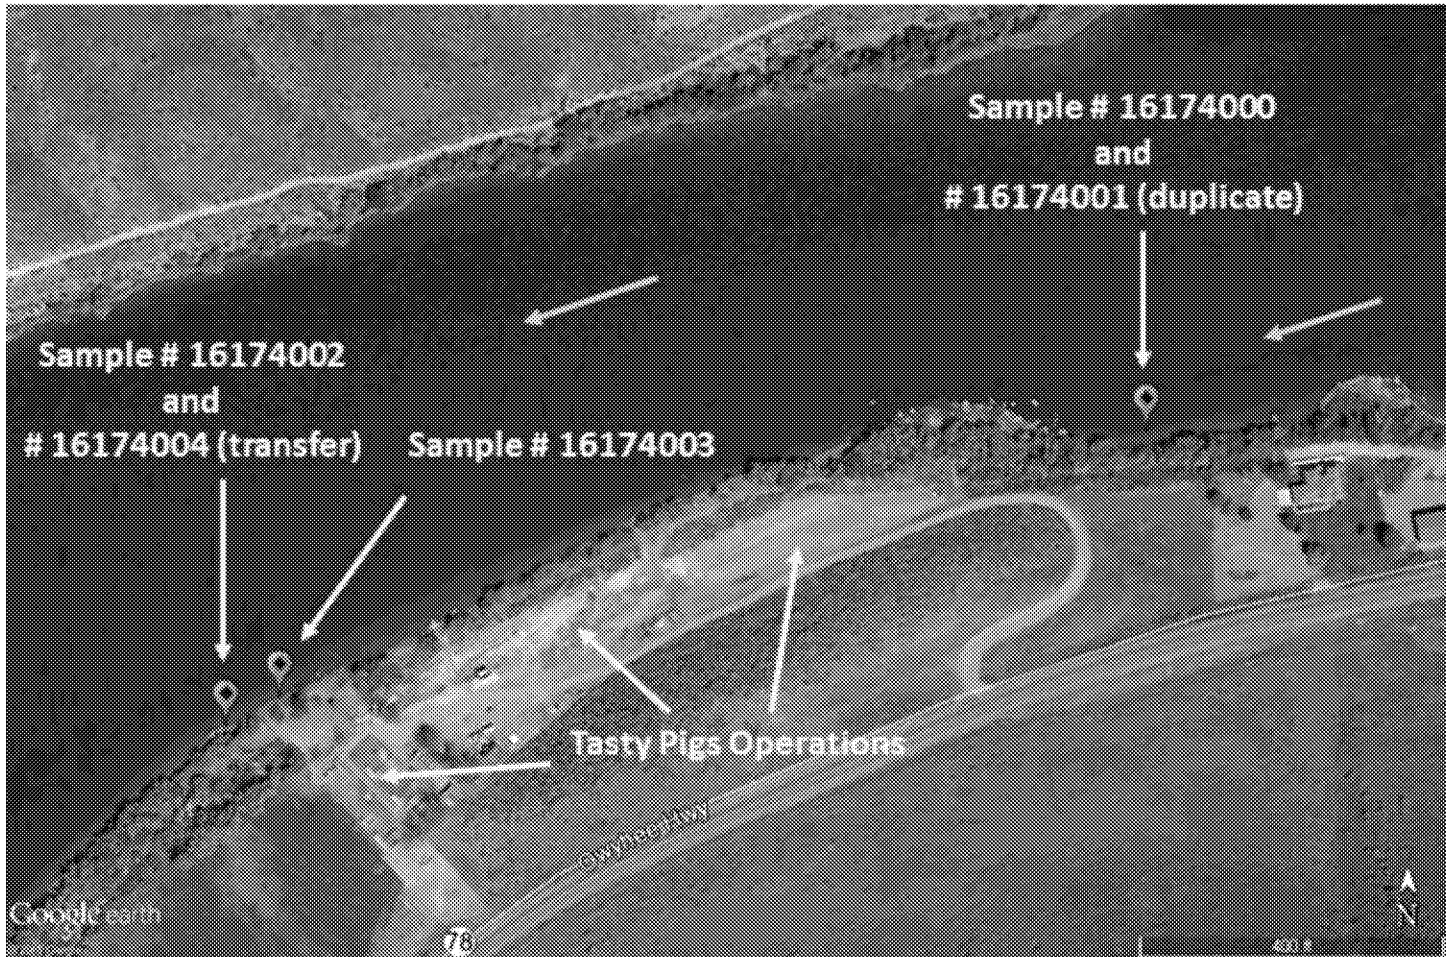
The first sample, sample # 16174000, was collected from a location approximately 240' upriver from the first of the animal pens (see Google Earth satellite image, Photo 21, for all sample locations). The sample was collected from a location approximately 5' from the shore. I decided to use this same location for the collection of duplicate sample #16174001. Both sets of samples were documented photographically (see Photos 22-24) before each set was packaged in its own individual polypropylene bag and placed on ice.

Table 2 – E. coli and fecal coliform; summary of analysis (refer to Photo 21 in Appendix A for sample locations)

CSSIP Sample No.	Collection Date/Time	E. coli MPN/100 mL	Fecal coliform MPN/100 mL	Notes
16174000	04/26/2016; 10:20 am	140	240	Upstream
16174001	04/26/2016; 10:20 am	150	240	Upstream Duplicate
16174002	04/26/2016; 11:05 am	2,400	>1600	Downstream
16174003	04/26/2016; 11:30 am	2,400	>1600	Inside Pen
16174004	04/26/2016; 11:05 am	<1	<2	Transfer blank

Photo No. 21 – from Google Earth Pro (satellite imagery date 05/29/2015)
Snake River sampling locations during April 26, 2016 Compliance Sampling Inspection at Tasty Pigs.

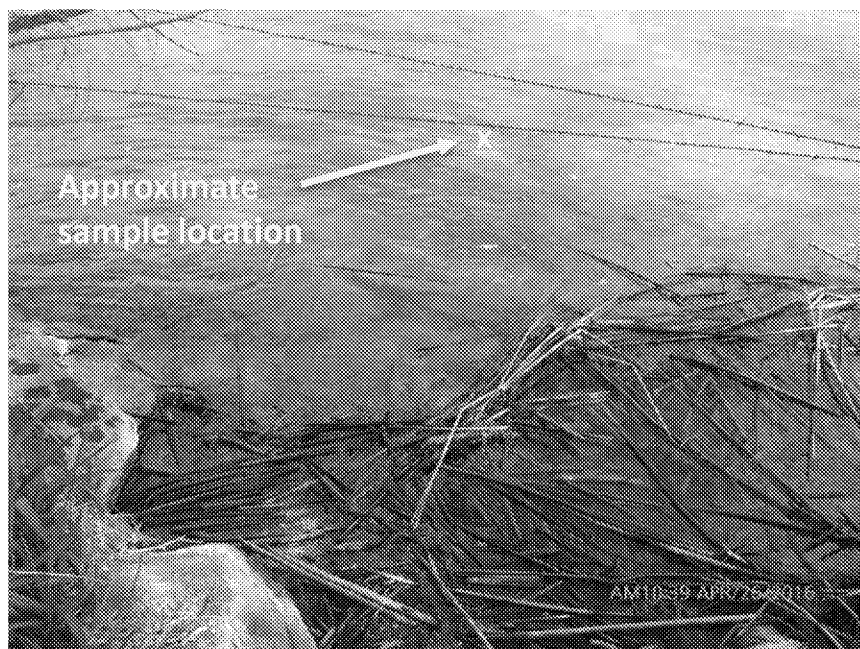
Photo No. 22 (P1020129)

Facing north – upstream sample # 16174000 and duplicate # 16174001 were collected from a location above the same submerged rock.

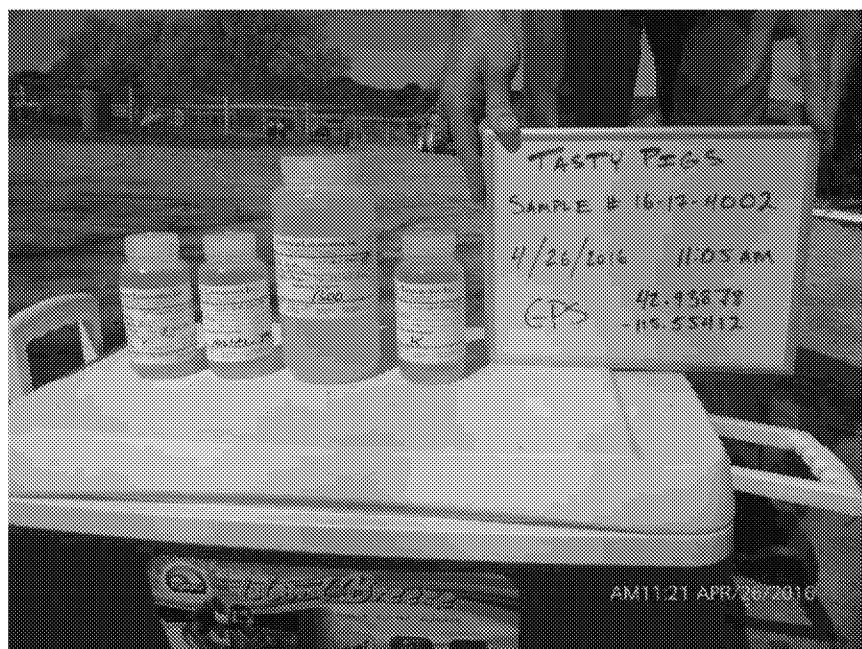
Photo No. 25 (P1020138)
Downstream sample set # 161740002

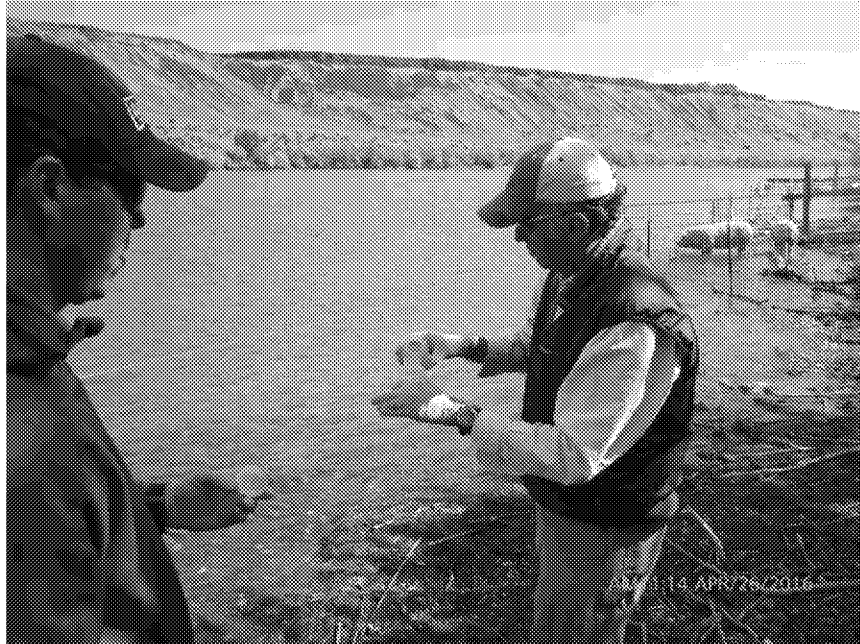
Photo No. 26 (P1020136)

The transfer blank involved the transfer of deionized water from a sterile bottle that had been filled at the same laboratory that had provided all the other sample bottles. The process of transferring the water, in the field, from the lab-filled bottle to a sterile microbial bottle provided by the lab, was performed as a control to demonstrate whether or not any microbial contaminants could have been introduced prior to or during the sampling process. The transfer blank, which I had labeled prior to the on-site inspection, was identified as sample # 16174004.

Transferring water provided by the laboratory to an empty, sterile microbial bottle; sample # 16174004; to be analyzed for E. coli and fecal coliform only. Transfer occurred at downstream location near the location where sample # 16174002 was collected.

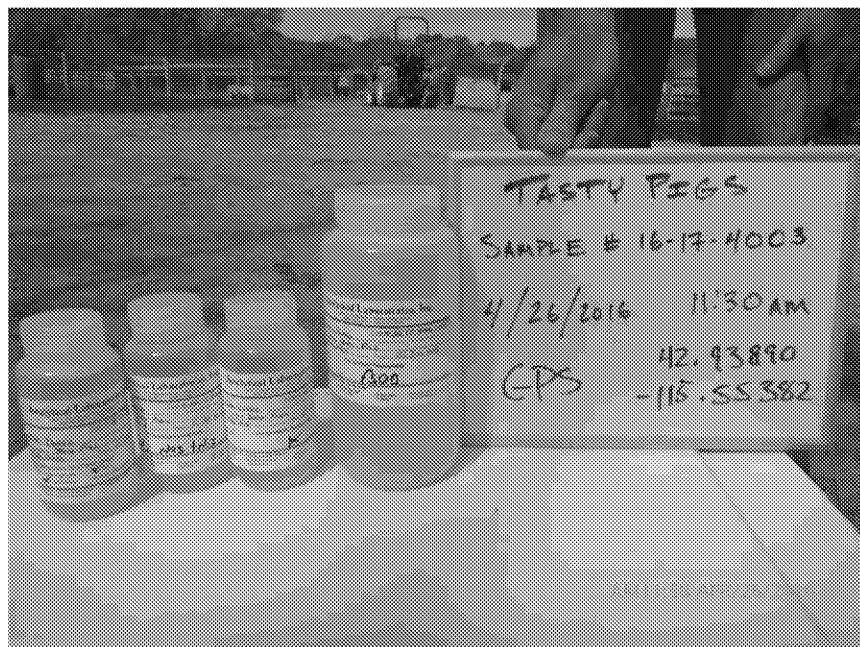
Photo No. 27 (P1020141)

Snake River sample set # 16174003 was collected from within one of the occupied pens.
